POTOMAC RIVER BASIN

Name Of Dam: <sup>3</sup>STRABURG *Dam*  
Location: SHENANDOAH COUNTY, STATE OF VIRGINIA  
Inventory Number: VA 17105

**LEVEL II**  
**PHASE I INSPECTION REPORT**  
**NATIONAL DAM SAFETY PROGRAM.**

AUGUST 1978

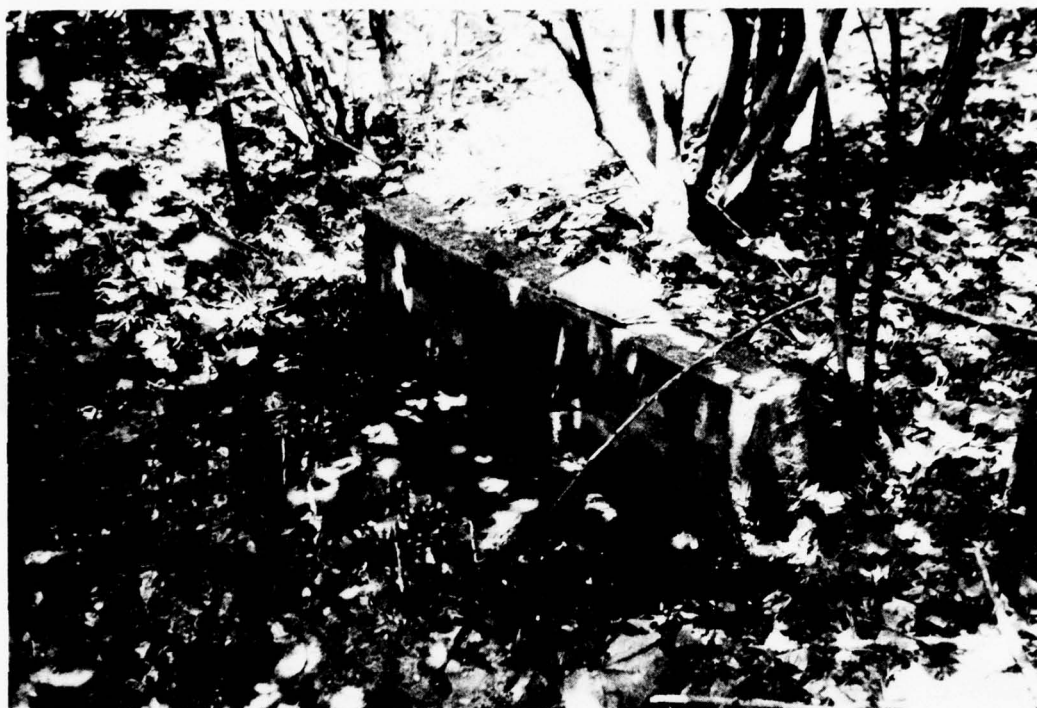
**PHOTO 1**

- Photo 1: Partially Clogged Left Subdrain Outlet
- Photo 2: Clear Seepage at Three Inch Pipe Location
- Photo 3: Partially Buried Right Surface Drain Outlet
- Photo 4: Upstream Slope of Embankment, Outlet Tower and  
Spillway Approach Channel
- Photo 5: Emergency Spillway Approach Channel

STAFF GAGE AND RECORDER	None was observed.		A gage or recorder should be installed.
OUTLETS	Drainage trench is located at base of clay core according to the plans. Left outlet was flowing. Iron oxide slime and vegetation covered seven inches of the pipe diameter. Right surface drain outlet was buried by earth from nearby tunnel excavation. Water upwelling through soil at position of three inch cast-iron pipe.		Drain outlets should be cleaned and repaired.

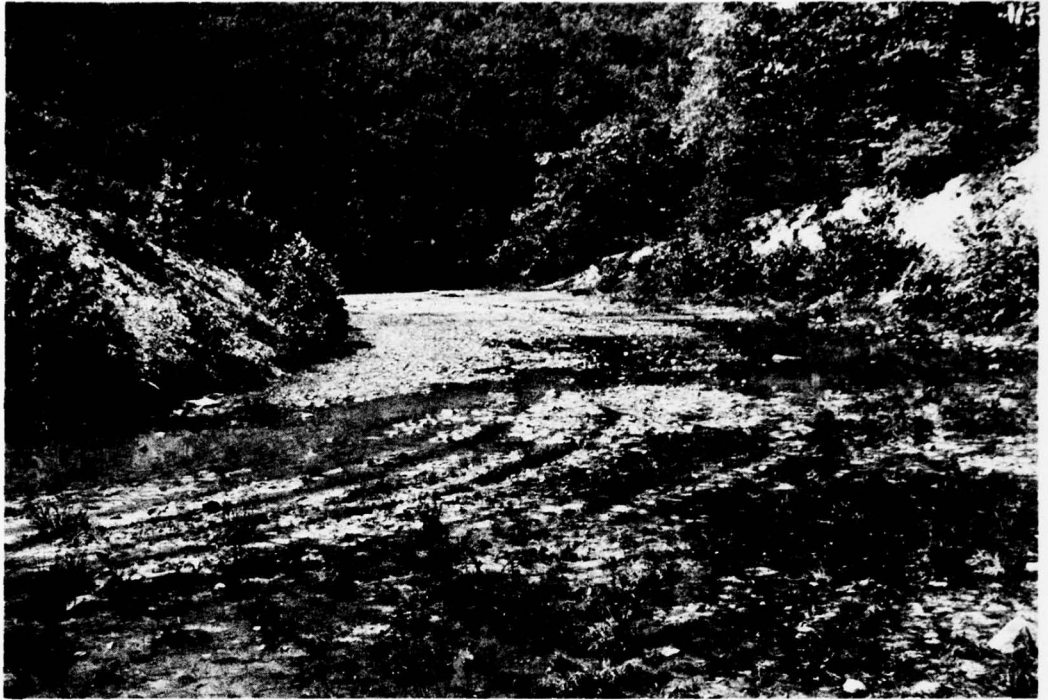
PHOTO 5

- 1) Emergency Spillway: Some clear spring seepage from above the reservoir is flowing into the spillway channel, but no erosion or blockage was observed. The clear seepage was estimated at five g.p.m.
- 2) Inlet Tower: The concrete was chipped by the impact of bullets. Otherwise, the concrete appeared to be in good condition. The three feet square concrete outlet conduit and the 12 inch cast-iron water supply pipe inside of the conduit appear to be in good condition.
